**GRASS VALLEY CREEK WATERSHED  
RESTORATION PROJECT:  
RESTORATION IN DECOMPOSED GRANITE  
SOILS**

*A Report Prepared by  
Trinity County Resource Conservation District  
and  
Natural Resources Conservation Service  
Weaverville Field Office  
in Cooperation with  
The Trinity River Restoration Program*

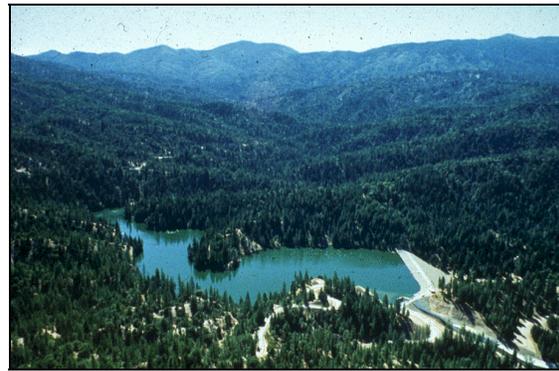
Figure 2-3. Buckhorn Sediment Dam

One of the first steps toward decreasing sediment delivery to the Trinity River was the construction, in 1984, of the Hamilton Ponds at the mouth of GVC near the confluence of the Trinity River and further upstream the construction of Buckhorn Sediment Dam (Figures 2-2 and 2-3). Both the sediment ponds and the debris dam were constructed as catchment sites for sediment before it enters the mainstem of the Trinity River. Because sediment from the watershed continues to enter the creek, the Hamilton ponds downstream from Buckhorn Sediment Dam need to be periodically dredged of sediment to retain their effectiveness.

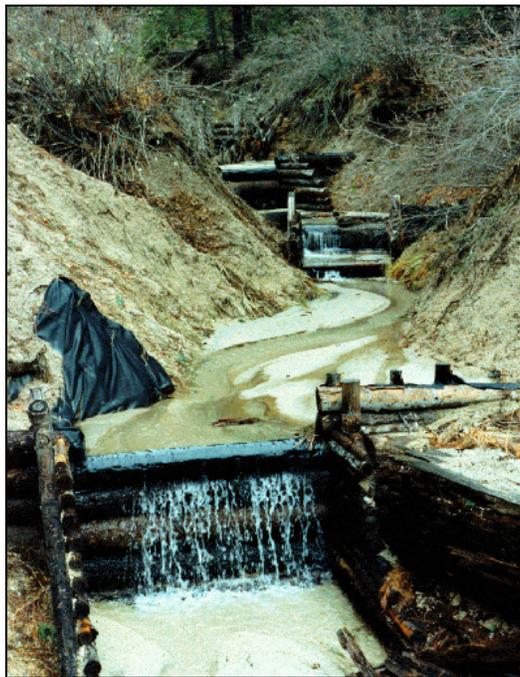
Through the winter of 1992/1993, preliminary evaluation and assessment of the log grade stabilization structures began. The cost-effectiveness and feasibility of building these types of structures for erosion control needs was evaluated. Log structures were found to be costly and difficult to build (Figure 3-1). Several factors contributed to this, such as the remoteness of the sites, the lack of available on-site logs with which to build structures, and the difficulty of keying them into unstable soils.

Figure 3-1. Log Grade-Stabilization Structure

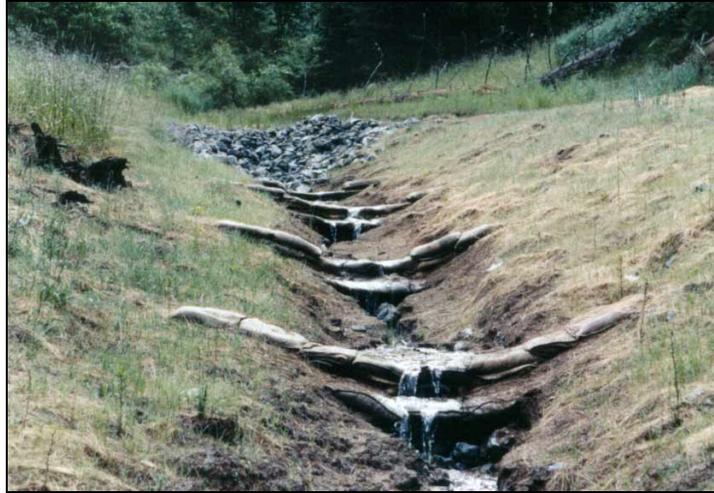
Because of this, the participating agencies began to use soil/cement grade stabilization structures in place of the log structures (Figure 3-2). Soil/cement structures were found to be superior to the log structures because: 1) they were quicker and easier to construct and therefore more cost-effective; 2) they enabled the utilization of on-site sand (given the remoteness of most of the sites); and 3) the structures could be molded to the required shapes before they hardened. Monitoring results indicated that the sand/cement structures were more effective and required much less maintenance than the log structures.

Figure 3-2. Soil/Cement Grade Stabilization Structure.

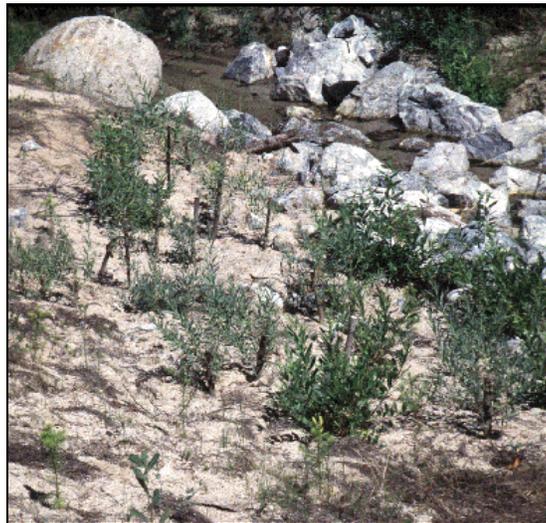
Bioengineering methods utilizing native willow cuttings (willow wattles and willow stakes) from the watershed were used extensively for streambank stabilization and to re-establish riparian plant communities in stream channels (Figure 3-3). These bioengineering techniques were very effective when applied in the wetter channels.

Figure 3-3. Willow Wattles and Willow Stakes in Channel

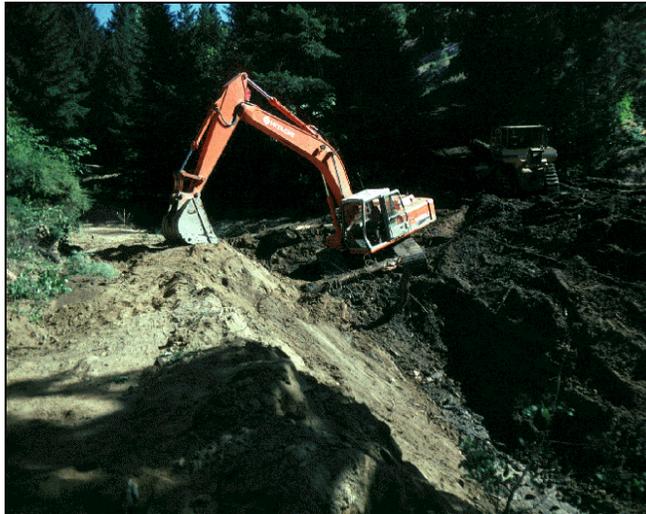
The emphasis of the project then shifted from labor-intensive hand treatments to stop the flow of sediment to heavy-equipment use to remove fill from road crossings, recontour road prisms, and decommission roads no longer needed for vital transportation (Figure 3-4).

Figure 3-4. Heavy Equipment Removing a Road Crossing.

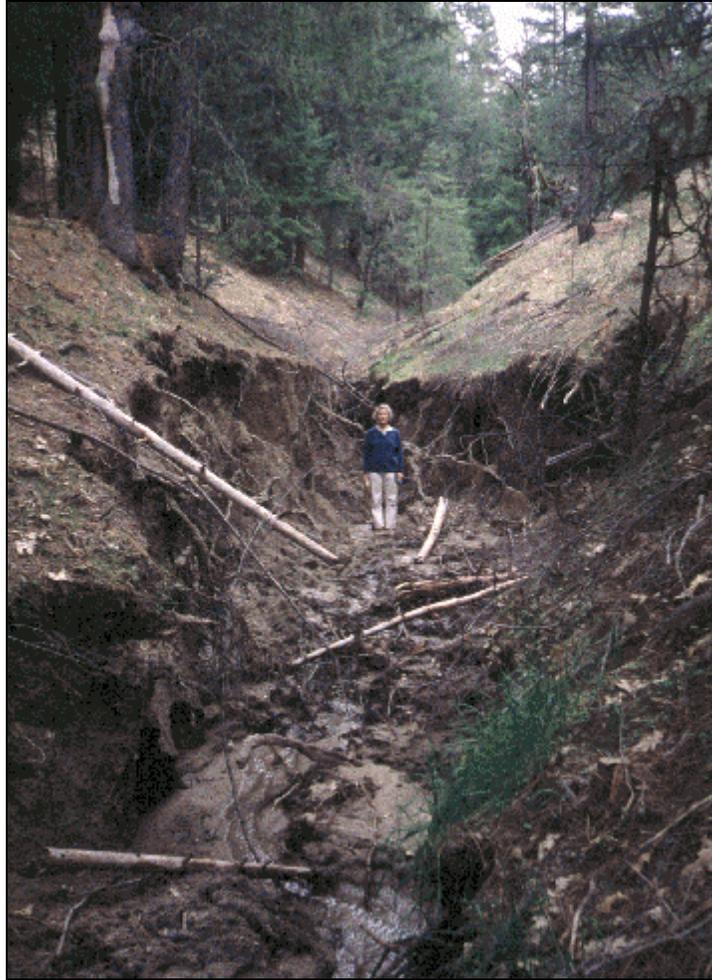
Because of an extended period of drought little was discovered about the viability of project methods during heavy rainfall. In early 1995 significant storm events provided this information. Some project sites, especially those in channels, underwent significant adjustments (Figure 3-5). The storms of early 1995 provided important information regarding the effectiveness of the various approaches and techniques attempted. This event taught much about the fragility and highly erosive nature of the watershed and the importance of channel protection in spite of the additional costs.

Figure 3-5. Gully Resulting from a Lack of Channel Protection.

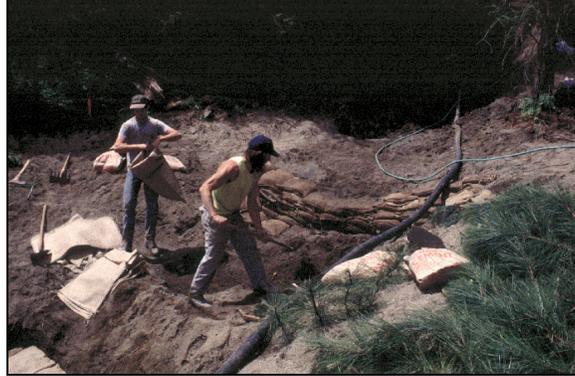
Figure 3-6. Grade Stabilization Structures are Incorporated into most Road-Crossing Excavations

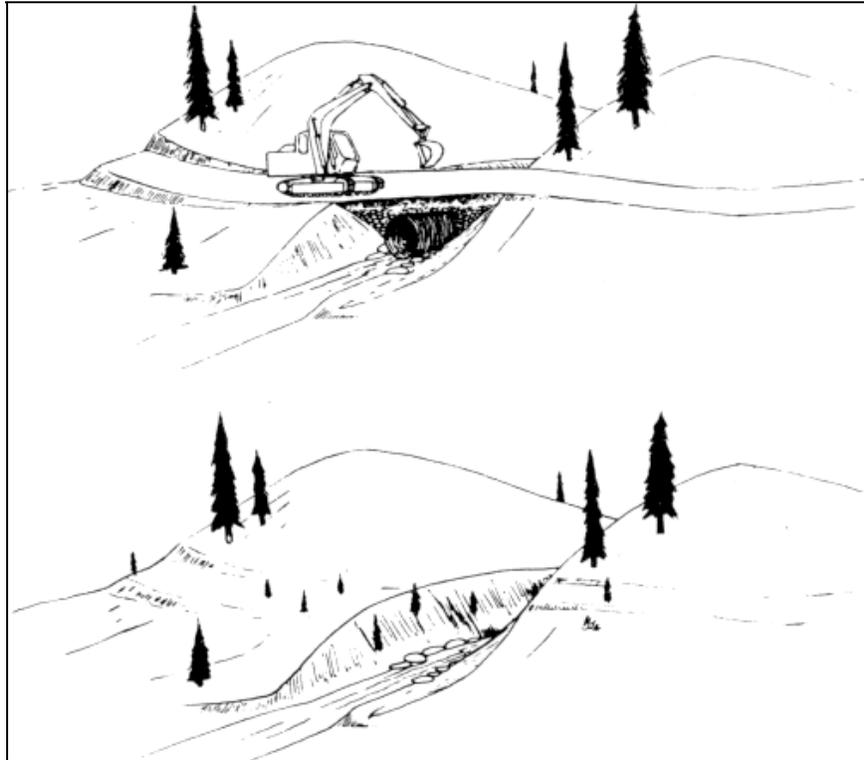
Figure 5-1. Removing a Road Crossing

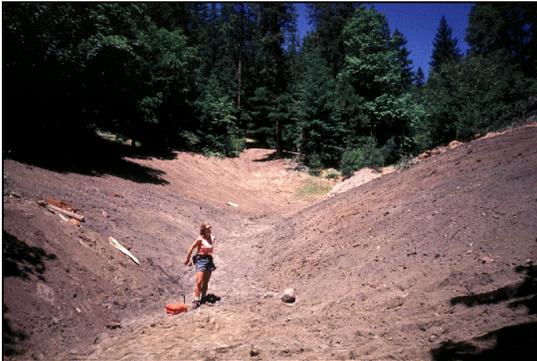
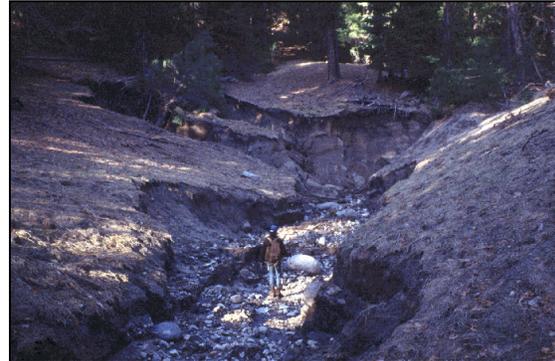
As a result of the January and March Storms of 1995 some very large adjustments were observed that exceeded the definition of acceptable erosion (Figures 5-2 and 5-3). In some cases the volume of erosion exceeded the original sediment yield estimate of the site. In order to quantify the impacts of the storms, all the large adjustments were surveyed to determine the volume of erosion from each site. This data was analyzed to determine the contributing factors which led to the unacceptable level of erosion recorded at these sites. From this analysis it was determined that the most relevant factors contributing to excessive erosion were: length of stream channel excavation, drainage area, and the underlying soil and geology of the site. Because of the complexity and interdependence of the variables involved, a statistical model could not be derived to quantify the relative weight of these factors.

Figure 5-2. Unprotected Channel on 6/15/94.

Figure 5-3. Same Channel on 2/14/95 after Major Storm

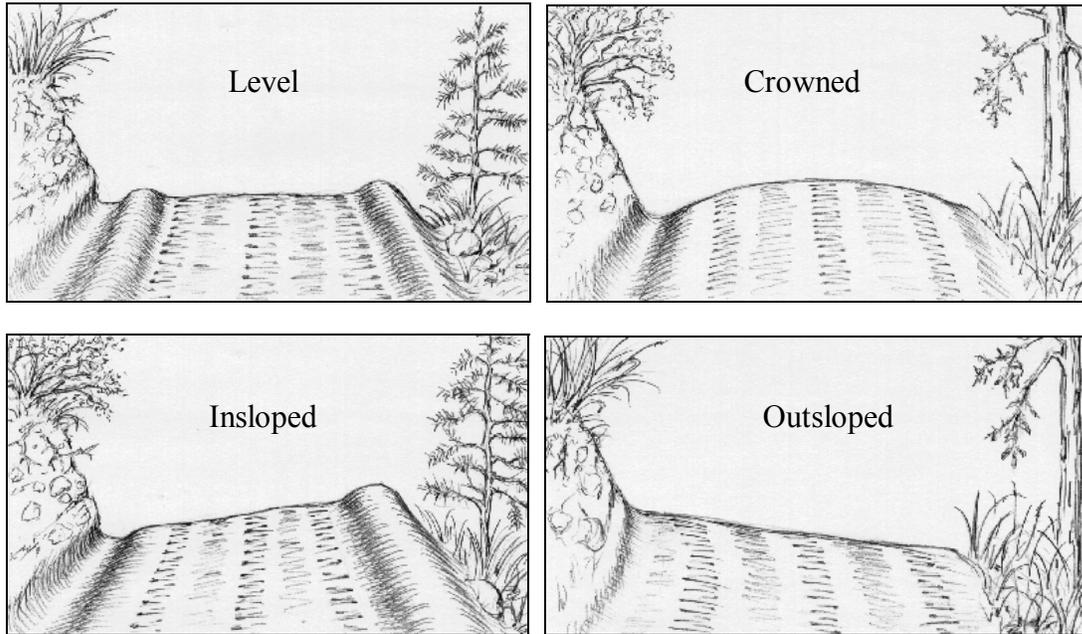
Road drainage design can be grouped into four basic categories, defined by road cross section: level, crowned, insloped, and outsloped (Figure 5-2).

Figure 5-4. Road Drainage Designs

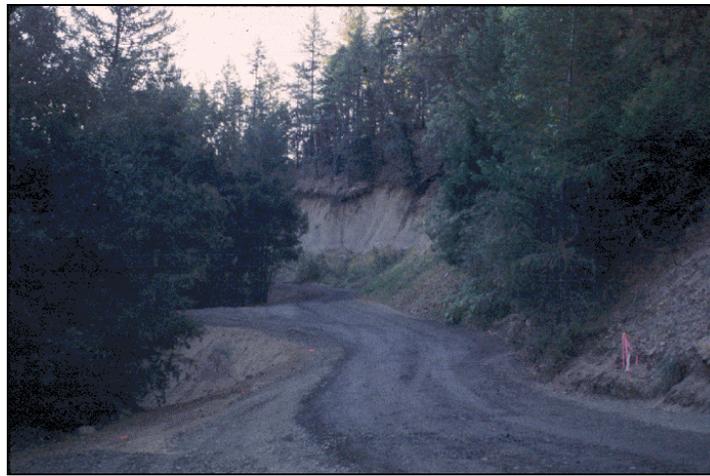
Figure 5-5. Outsloping Reduces Concentrated Flow on Road Surface

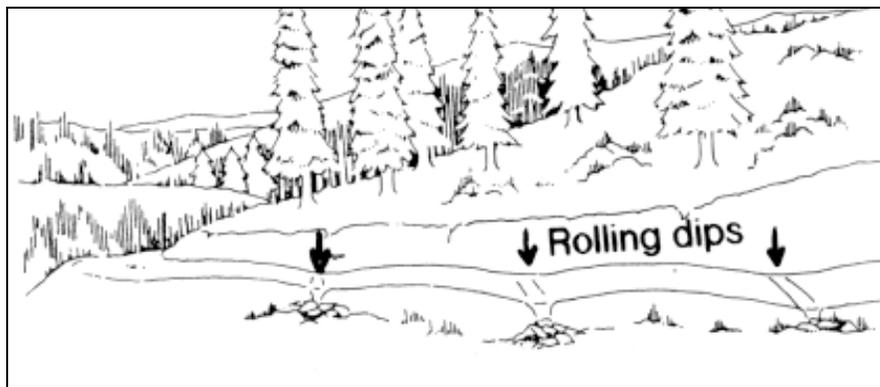
Dips in the road surface which diffuse water from the road and/or inboard ditch (Figure 5-6).

Figure 5-6. Rolling Dips.

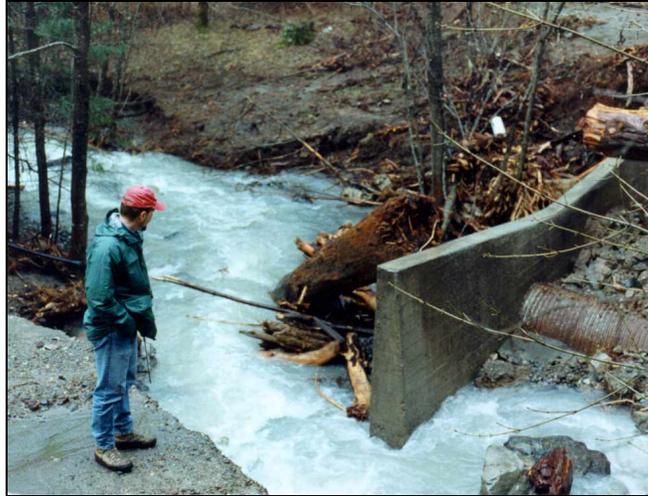
Figure 5-7. Culverts Will Inevitably Plug With Debris. Critical Dips At Crossings Will Ensure That Flows Remain In Stream Channels.

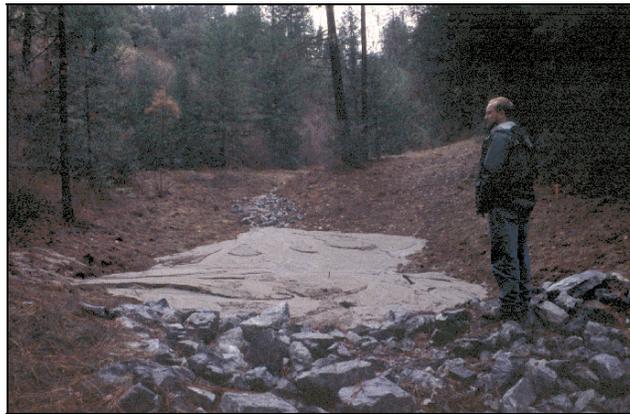
A basin excavated below original ground surface.

Figure 5-8. Excavated Sediment Traps Have Proven To Be Very Effective In GVC.

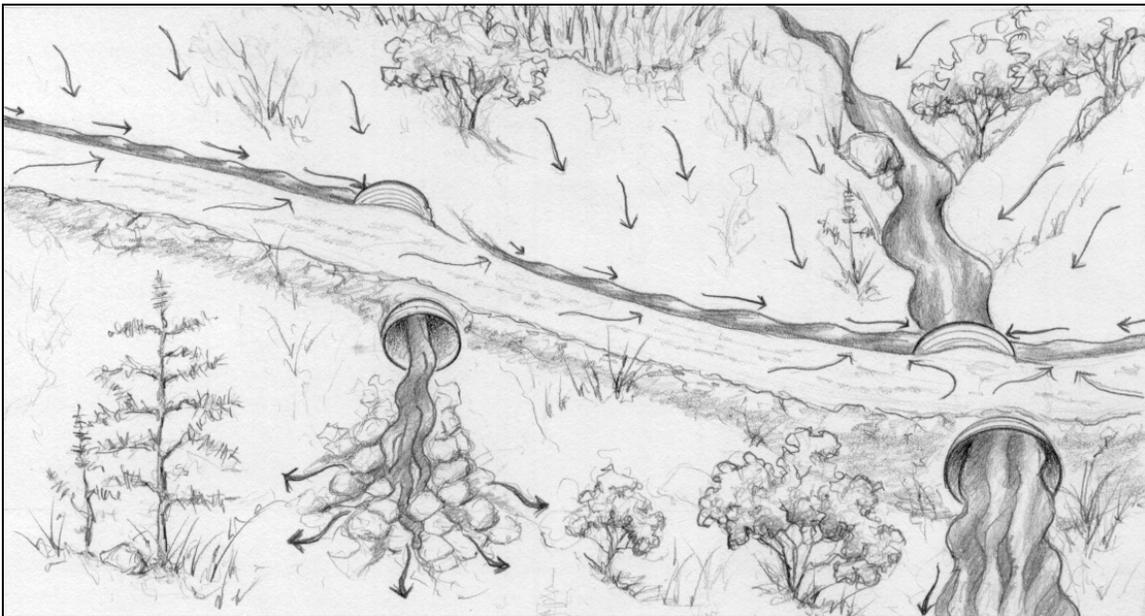
The main problems associated with maintained roads are inboard ditches, inter-basin diversions, and culvert discharges (Figure 5-9). Maintained roads are commonly highly compacted and capped with a semi-impermeable or impermeable surface layer. This results in increased surface runoff from the road surface. An insloped road intercepts lateral hill slope surface and subsurface flows and, combined with road surface runoff, concentrates the flow to a discharge point. The more widely spaced the discharge points are, the greater the concentration of flow. Culvert discharges, whether from road drainage or road crossings, can cause stream channel scour for several hundred feet below the point of discharge if adequate energy dissipation is not provided.

Figure 5-9. Road Drainage Issues Affecting Stream Channel Stability

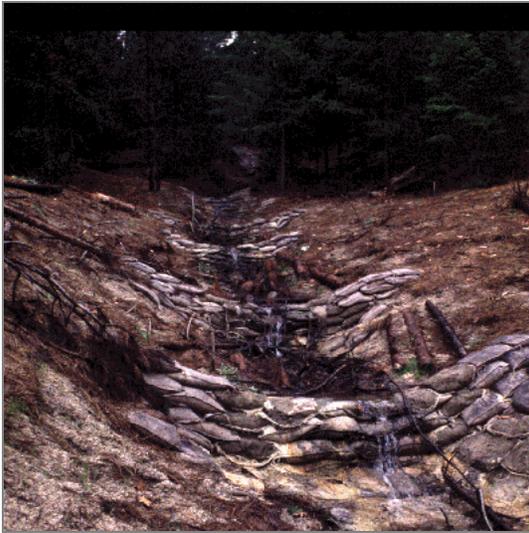
Figure 5-10. Soil/Cement Checkdam

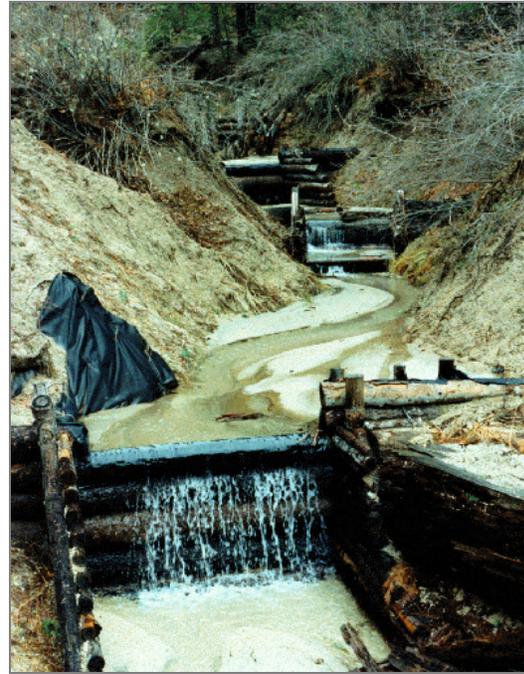
Log Checkdams (Figure 5-11) are generally more difficult to construct and have a higher potential for failure than soil/cement checkdams. This practice is currently being used only when cement or rock cannot be feasibly transported to a site. Life expectancy of these structures is generally 5 to 10 years. When log structures fail they typically lose all effectiveness rather than degrading incrementally as soil/cement structures. The most common cause for failure has been piping around the structure. This is difficult to avoid due to the nature of DG and the rigidness of the structure. However, the risk can be minimized by: keying the logs well into the bank (2 feet minimum), using geotextile fabric in keyways, well compacting the keyway, and by keeping spillway height less than 3 feet.

Figure 5-11. Log Checkdam

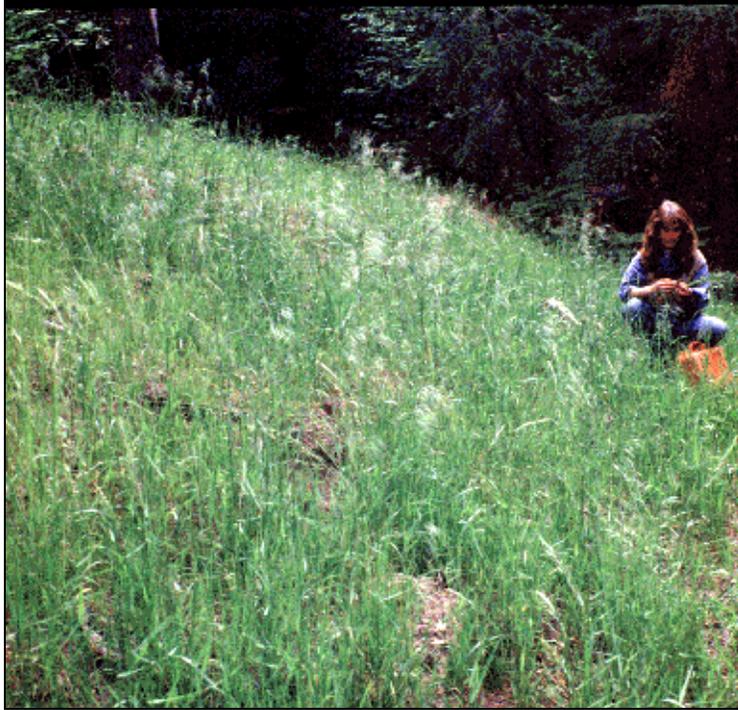
Figure 6-1. Landing Seeded with Hot/Dry Native Seed Mix

A non-native seed mix of perennial bunch grasses, annual grass, and forbs was initially used in the GVC watershed. Non-natives are less expensive than natives, and have been proven to provide effective erosion control in the watershed. The high degree of survival characteristic of many exotic grasses has made them practical for fulfilling short-term management objectives, but their invasiveness and long-term effect on both the biological and genetic diversity of ecosystems is an increasing concern (Knapp and Rice 1996). Field observations have indicated that the non-natives do not stay on slopes very well and tend to migrate to a low gradient portion of the treated slope with a more stable, protected environment.

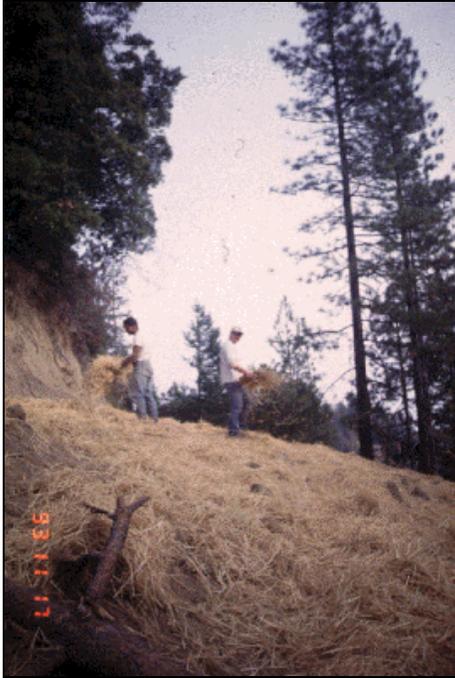
Figure 6-2. RCD Crew  
Spreading  
Mulch

Mulch has four basic purposes in the GVC watershed: to protect bare soil from raindrop impact and surface run-off, to increase water holding capacity (field capacity), to add organic matter to soil (which enhances the intrasystem cycling of nutrients and improves soil structure, pore space, and water storage), and to provide a microclimate for germinating seeds. Mulches are usually made of materials that have a short lifespan, and they begin to decompose immediately but typically last one to three years. Mulches should be applied soon after planting before soil moisture is depleted and before the sown seed is consumed by wildlife (Figures 6-2 and 6-3).

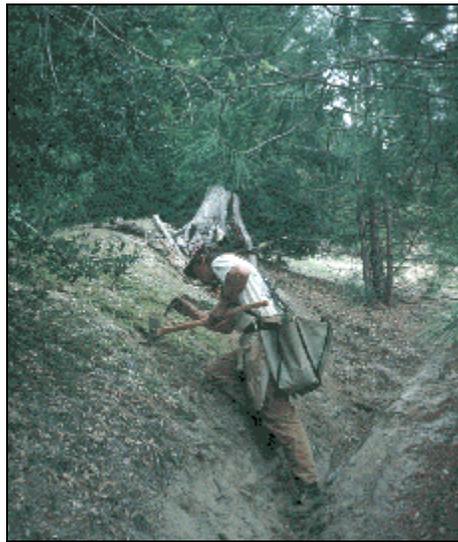
Figure 6-4. Planting to Stabilize Gully Banks

According to nurseryman Tom Jopson (personal communication 1993), long-needle pine species, especially ponderosa and Jeffrey pine, are potentially the best choice for many sites in the GVC watershed. They occur naturally on decomposed granitic soils and the long needles form an effective mulch which resists wind and downslope movement even on steep and exposed roadcuts. Also, pine seedlings have been produced in large quantities for many years by many nurseries and are readily available. If grown from seed collected for a particular area, seedlings can easily be ready for planting the following year. Potential long-term benefits are a deeply penetrating root system and permanent needle mulch cover that will effectively control erosion.

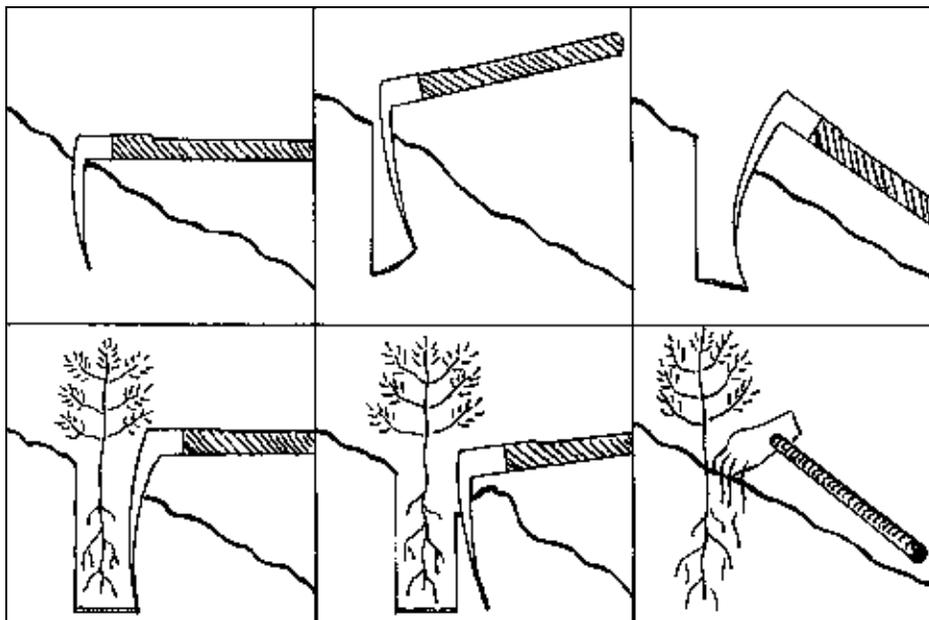
**Grasses/Shrubs/Trees:** For the GVC watershed, hoedads are the primary tool used to open the planting hole (Figure 6-5). Dibbles have also been used, but these tend to not create a wide enough or deep enough hole for the 6 inch, 8 inch, and bareroot stock used in plantings. The hole must be made deep enough for the roots to be fully extended. The plant should not be taken out of the planting bag until after the hole is made to ensure that the roots do not dry out. On dry days, water should be added periodically to the bottom of the planting bag, to ensure that roots stay moist. (It takes less than one minute for roots to become too dry to keep the plant alive.) The roots must be checked to ensure they are not curled or bunched up; if roots are in such a condition, they should be gently separated by hand. The plant should be held in place in the hole to ensure the roots are straight and not turned up ("J-rooted"). Seedlings must not be planted too shallow (top of root mass showing above ground) or too deep (buried up to lower branches). The soil should be firmly tamped around the roots to prevent air pockets that can dry out roots. Finally, a slight tug should be given to the seedling to ensure that it is firmly anchored.

Figure 6-5. Proper Planting Technique

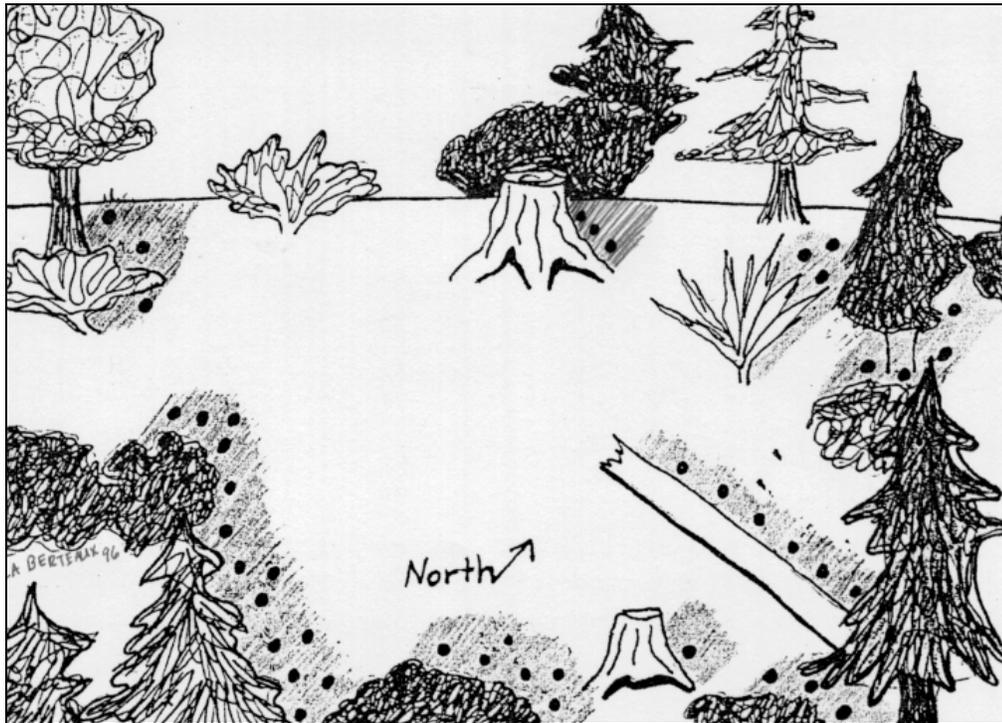
*Sheet and Rill:* In early trials, entire slopes were planted, regardless of existing canopy or lack of microsites, resulting in very poor survival. Microsite planting is the preferred method used on these harsh sites. If a microenvironment--which provides more of what a plant requires, such as protected zones with more moisture and nutrients--can be utilized by seedlings, then survival may be increased for planted species. North-facing sides of slopes or underneath existing vegetation or in existing woody debris (in the shade zone) should be planted. Conifers should be planted only on sites with soil depth of at least 8 inches, with existing vegetation and surface organic material present.

Figure 6-6. Planting Shaded Areas (North Sides) on Sheet and Rill (Dots Represent Planting Sites)

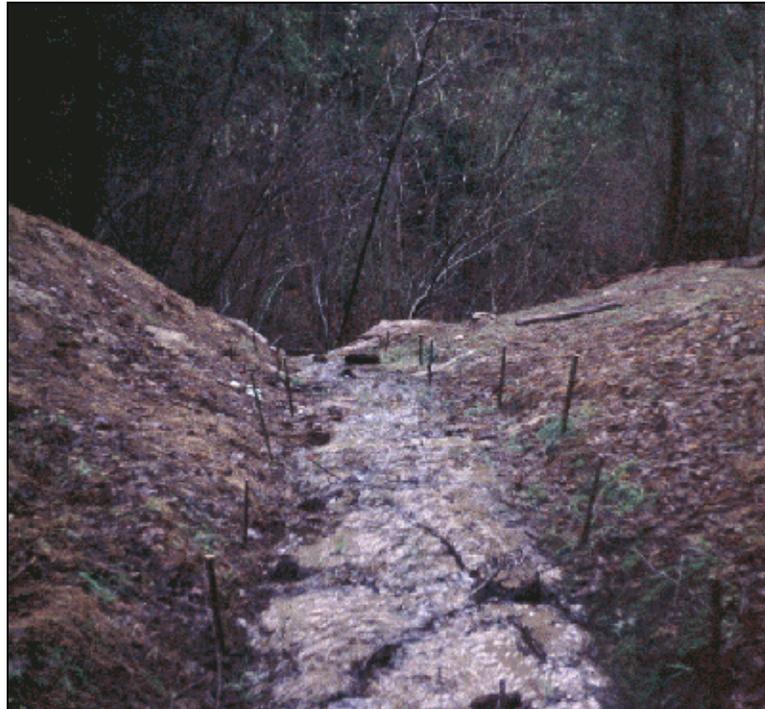
For stakes: Stakes 3 to 4-foot in length and 3/4 to 2 inches in diameter are used in the GVC watershed for ease of transport and installation. 2/3 of the cutting should be planted in the ground with one to three buds remaining above ground level. The stakes are installed using an auger or digging bar. It is essential to have good contact between the cutting and the soil. Air pockets around the cutting can kill the roots, so soil should be tamped around the cutting firmly several times as the hole is filled. If bank stabilization is the goal of the planting, the cutting should extend more above the ground (1 to 2 feet) at a 45-degree angle from the channel bottom to provide immediate protection as it leafs out. Stakes should be planted close together (1 to 3 feet apart) to form a “wall” of protection.

Figure 6-7. Willow Stakes Installed Along an Excavated Channel

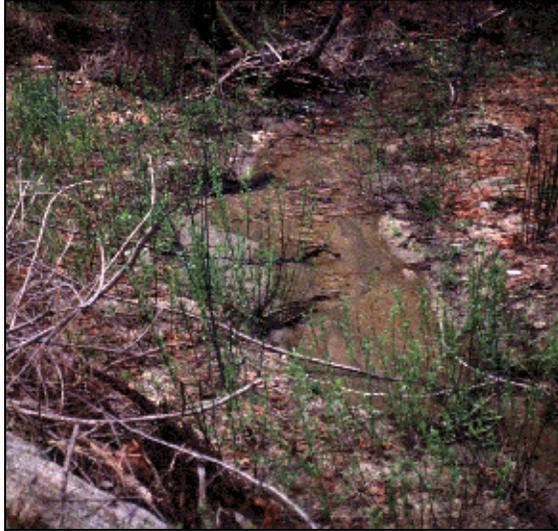
Figure 6-8. Sprouted Willow Wattles

For Wattles: Primarily willow species are used for wattle material. The lengths vary from 3 to 6 feet depending on accessibility to the site and size of area treated. Bundle diameters are made small (4 to 6 inches) in order to allow ease of transporting them to the site. The cuttings are put together in specially built troughs designed to hold several cuttings in place in order to tie the ends of the bundles together. Cuttings are placed in the troughs with the top ends sticking out each end of the bundle.

When installing the bundles, a trench 4 to 6 inches deep is dug with a trenching shovel. The trench may be dug parallel to the stream or perpendicular to the stream, depending on the type of protection needed. The wattle is placed in the trench with the ends exposed, and the rest of the wattle is then covered with soil and packed down. The buried section will sprout roots and the exposed ends will leaf out to quickly form shrubby growth.

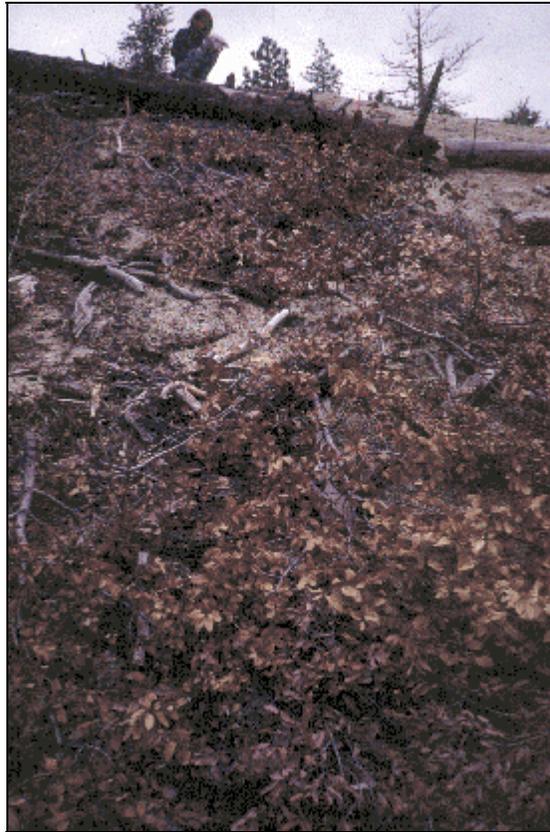
Figure 6-9. Slash Spread on a Sheet and Rill Slope

“Lop and scatter” treatment utilizes a technique using material (slash) derived from branches of live trees and shrubs and dead material on the ground which is then spread on soil surfaces as mulch. Slash is used as a substitute to straw mulch on areas where access to sites is a problem. It is used primarily in the GVC watershed to create microenvironments (areas specifically meeting the germinating requirements of a species) or “safe sites” for sown and planted species and to add detritus in the form of woody material, which, with the process of decomposition, will add nutrients to the soil. Lop and scatter also creates surface roughness and complexity.

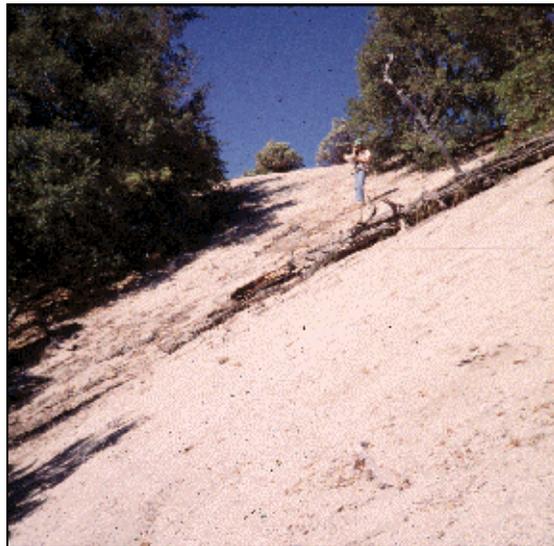
Figure 6-10. Typical Sheet and Rill Slope

Treatment of harsh sheet and rill (surface erosion) sites have taken place since 1994 on a small scale with the establishment of several test plots using various revegetation techniques. These sheet and rill slopes have lost canopy cover which provided duff to protect the soil from rain drop impact and created “safe sites” for seeds to germinate. The duff layer essential for the health of soils is absent on sheet and rill sites in DG soils.

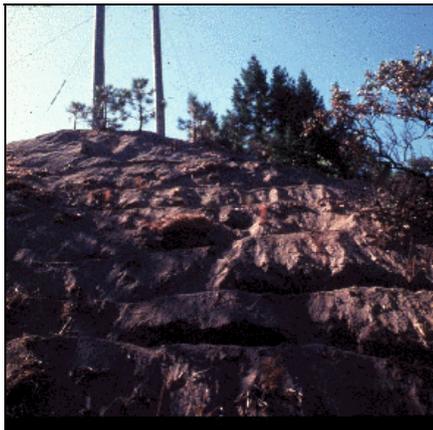
Contour Furrows: Trenches are dug along the contour of the slope approximately three feet apart. Seed is sown in the trenches and sometimes covered with mulch such as straw or pine needle duff. This is a cost-effective but labor-intensive treatment. Also, trenches tend to fill in, burying seed (Figure 6-11).

Figure 6-11. Contour Furrows

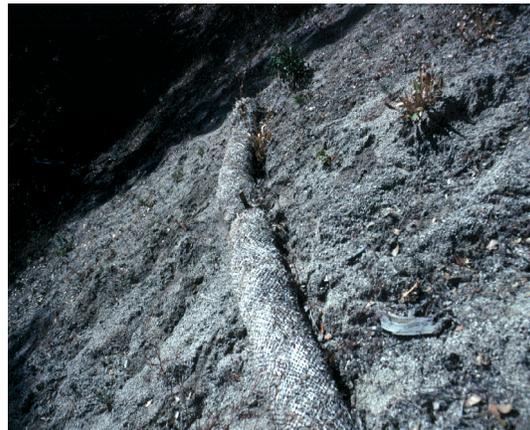
Figure 6-12. Straw Wattles

Straw wattles: 20- to 25-foot-long trenches are dug along the contour of the slope for each wattle. Wattles are placed in the trench and wooden stakes are used every few feet to hold the wattles in place (Figure 6-12). Seed is sometimes sown behind the wattles where needles, leaves, and other organic material is deposited. Wattles are very difficult to install properly, especially on sheet and rill slopes with little soil depth. They are expensive to purchase and

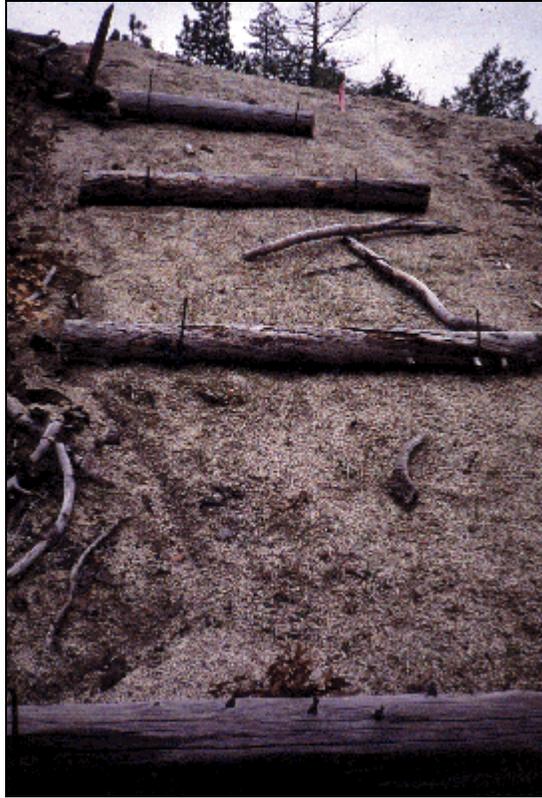
Figure 6-15. Cross Slope with Logs

**Cross-slope (X-slope) with Logs:** When material is available, logs can be installed in much the same way as straw wattles. This technique is much more cost effective, but can be very labor intensive. Transportation of materials and shallow soils (which makes the digging of trenches more difficult) contribute to the increase in labor. Germinated seedlings are usually found behind or underneath the logs where there is better soil and cover. Decomposing logs will establish organic matter on the site, increasing soil nutrients to the site. Results will probably take some time to achieve.

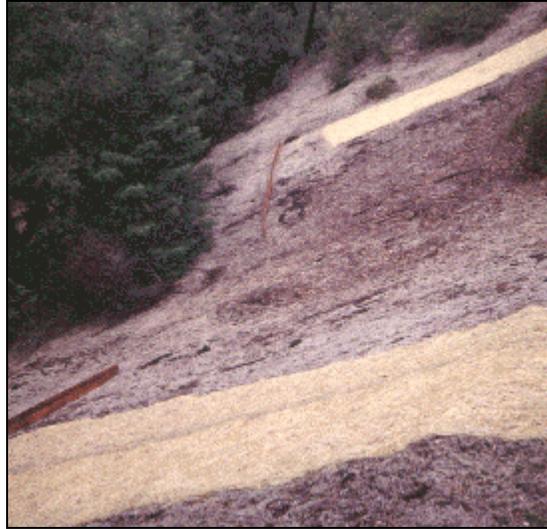
Figure 6-16. Erosion Blankets

Erosion Blanket: Germination of seeds sown under erosion blankets has shown very poor results. Wildlife use the blankets for bedding. Blankets are expensive and labor intensive to install. Some moisture is retained under the blanket, but the weave of the material may be too close to allow germination of seed.

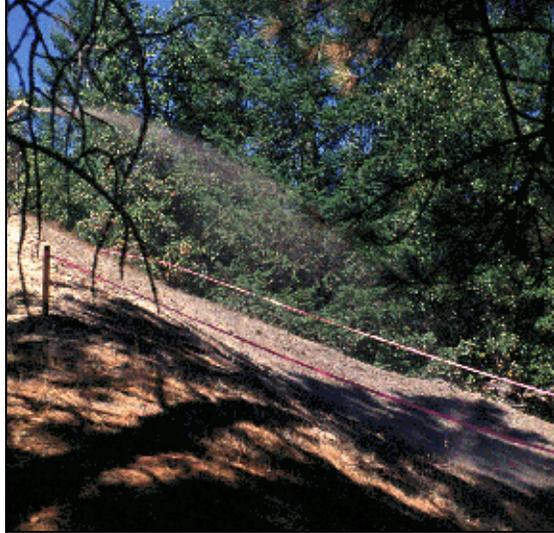
Figure 6-17. Lime-Based Tackifier Being Applied

**By Helicopter:** A helicopter was employed to apply lime-based tackifier to areas inaccessible by truck. The slurry, plus seed and fertilizer, was mixed in a tank, and smaller amounts were transferred to a bucket, which was attached to the helicopter and carried to each site. The slurry came out of the bucket very quickly; each site had to be

visited three or four times. The helicopter operator was not able to access sites more than one mile from the staging area and was not able or willing to treat all of the sites that were inventoried. The expense of this technique was not as cost effective as originally estimated due to several equipment breakdowns. The application by helicopter was very thin and spotty. It was doubtful at first whether this would be an effective treatment, although field observations have indicated that germination of seed has taken place on areas treated by helicopter. Careful planning must be done when using a helicopter, and the staging area should be close to the sites. Make sure that the operator has done this type of work before and knows what to expect.

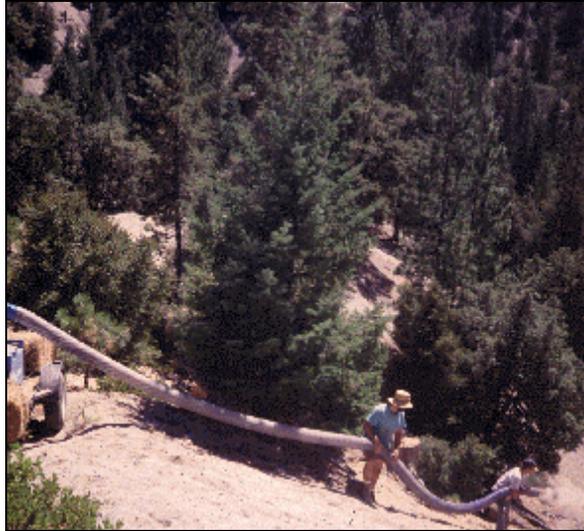
Figure 6-18. Using Straw Blower to Apply Mulch

*By Blower*: It was very difficult to get the blower to the sites as the areas were very steep. A wench and several technicians were employed to haul the blower up skid roads to the tops of ridges where the straw was sprayed on the slopes. Twice as many bales must be used when applying the straw by blower. The straw is broken up into finer particles. Most of the sites were not accessible by blower.

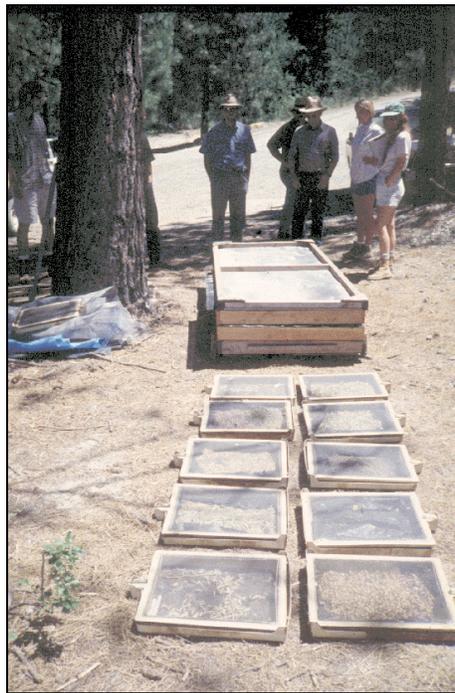
Figure 6-19. Seed Drying

Species such as lupine or *Chrysothamnus* (rabbitbrush) mature and produce seed over several weeks, on any given plant. These species can be gathered more than once during the season--every week or so--as new, ripened seed is apparent. Care should be taken not to gather fruit too early if it is gathered on the stalk then set out to dry. If unsure, it may be wise to do several collections to ensure that viable seed is collected. The method of gathering seed all at once when it is ripe requires intensive gathering by a large crew.

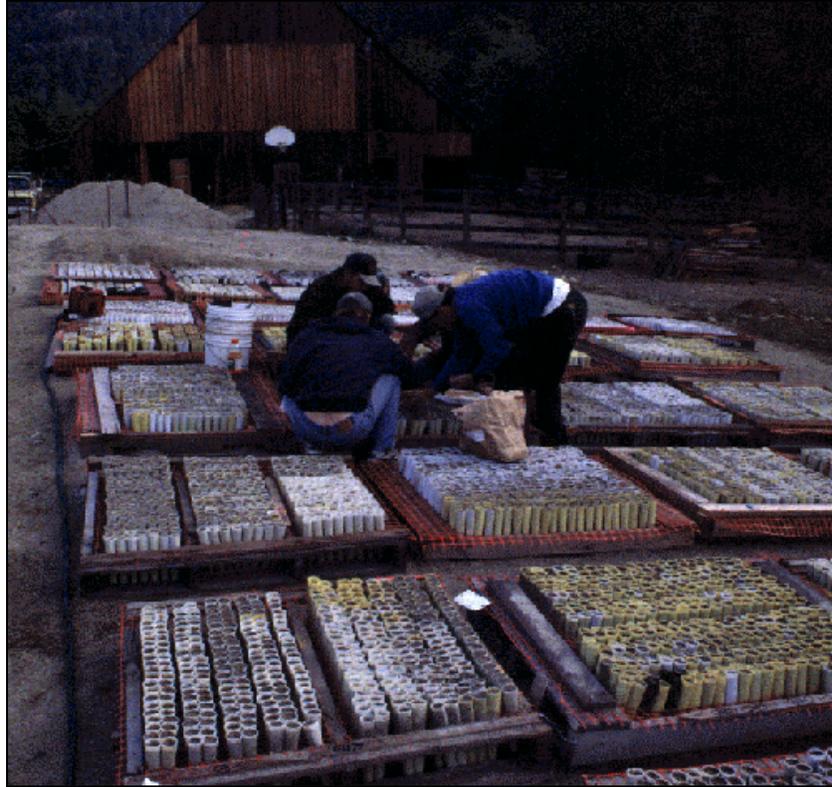
Figure 6-21. Native Plant Nursery

The total cost for the construction of the nursery and initial sowing was \$8,659.00. This translates into a per plug cost of \$0.50. Now that the nursery has been established, the cost per plug should be \$0.20.

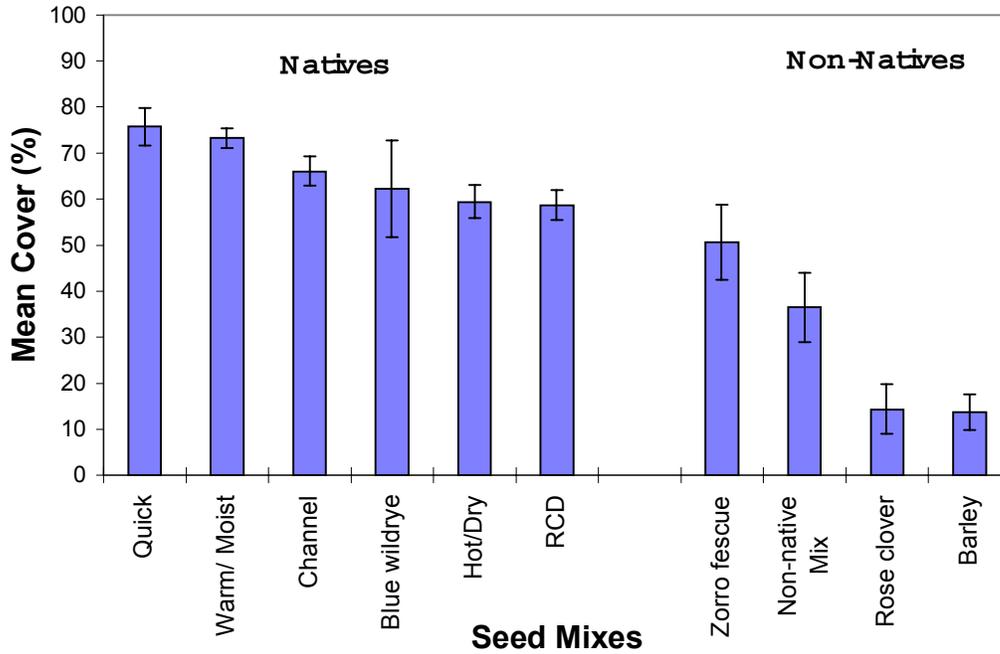
There was some contention after 1993 as to which provided greater cover: native or non-native seed mixes. The monitoring data shows that after two years of growth, the native mixes (channel mix, quick mix, hot/dry mix have greater cover than the non-natives (SCS mix, rose clover, Zorro fescue, and clover) (Figure 6-22). The quick mix and the warm/moist mixes had the highest cover among the natives, while the Zorro fescue and the SCS mix had the highest cover among non-natives. This difference may be explained by species composition within the native and non-native mixes. The native mixes contained perennial

Figure 6-22. Comparison of the vegetative cover of native and non-native seed mixes after two years of growth. Error bars represent  $\pm 1$  SE (standard error).

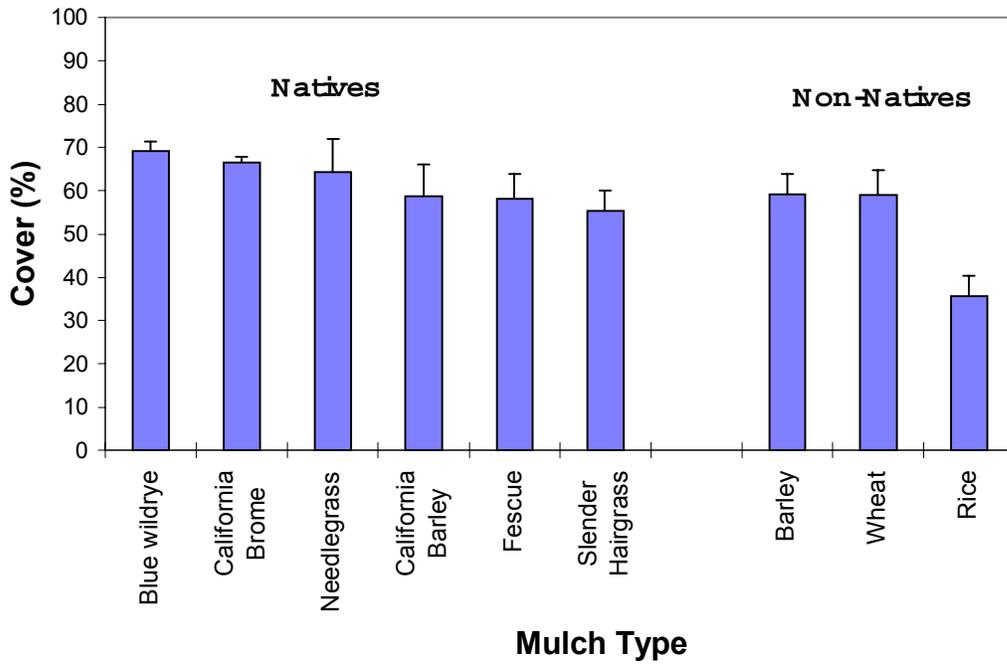
In comparing the cover of seeded species, it was found that native straws and non-native barley and wheat produced similar coverage (Figure 6-23). Native blue wildrye, California brome, and needlegrass straw produced the highest cover, which ranged from 64 to 69 percent. Cover of barley and wheat was 59 percent, with rice straw producing low cover of seeded species. Also, rice straw was dirty and difficult to spread, so its use was discontinued. Because it appears that results of native and non-native mulch cover is very similar, there are some factors to consider in deciding which to use. The main factor may be cost, with barley and wheat ranging from \$4.00 to \$5.00 a bale, while native grasses can range from \$5.00 to \$8.00. Native straws may cost more now, but with increased demand encouraging suppliers to produce native material, there may be a reduction in price over time (Craig Dremann, personal communication, Native Grass Workshop, 1995). The primary advantage of native straw is that bunchgrasses germinate from the bales, which was seen in field observations. Applying native mulches would be a native seed source without any additional seeding, depending on the desired amount of ground cover. One must be careful in obtaining "any" wheat or barley straw, for it can be contaminated with exotic species such as clover and annual grasses. *This caution should be used in obtaining native straw also: the RCD has received native bales that could not be used due to contamination with exotics.*

Figure 6-23. Comparison of Vegetative Cover from Seed Mixes Using Native and Non-Native Straw Mulches.

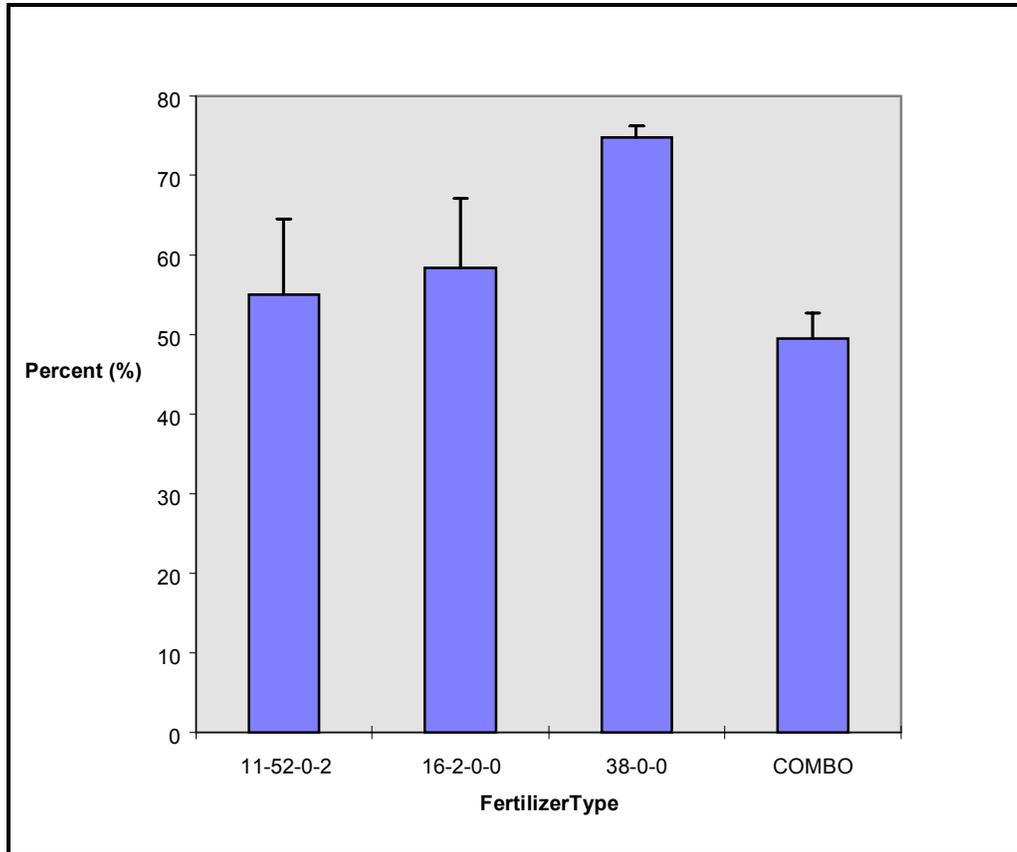
The similar amount of cover seen in the other fertilizers is most likely a result of the type of chemical fertilizers that were used. Three of the fertilizers (11-52-0-2, 16-2-0-0, and a combination of 11-52-0-2 and 38-0-0) were not slow-releasing, so that all minerals were released into the soil over a period of days and weeks. Considering the coarse texture of granitic soils and associated low capacity for holding nutrients (USDI BLM, 1994), it is likely that most of the fertilizer leached away before it could be utilized by the plants. The high phosphate fertilizer (11-52-0-2) may not have been necessary, for the GVC granitic soils are known to be deficient in nitrogen, not phosphorus (Claassen 1994).

Figure 6-24. Percentage of Cover of Seeded Species with Fertilizer Treatments
