**GRASS VALLEY CREEK WATERSHED  
RESTORATION PROJECT:  
RESTORATION IN DECOMPOSED GRANITE  
SOILS**

*A Report Prepared by  
Trinity County Resource Conservation District  
and  
Natural Resources Conservation Service  
Weaverville Field Office  
in Cooperation with  
The Trinity River Restoration Program*

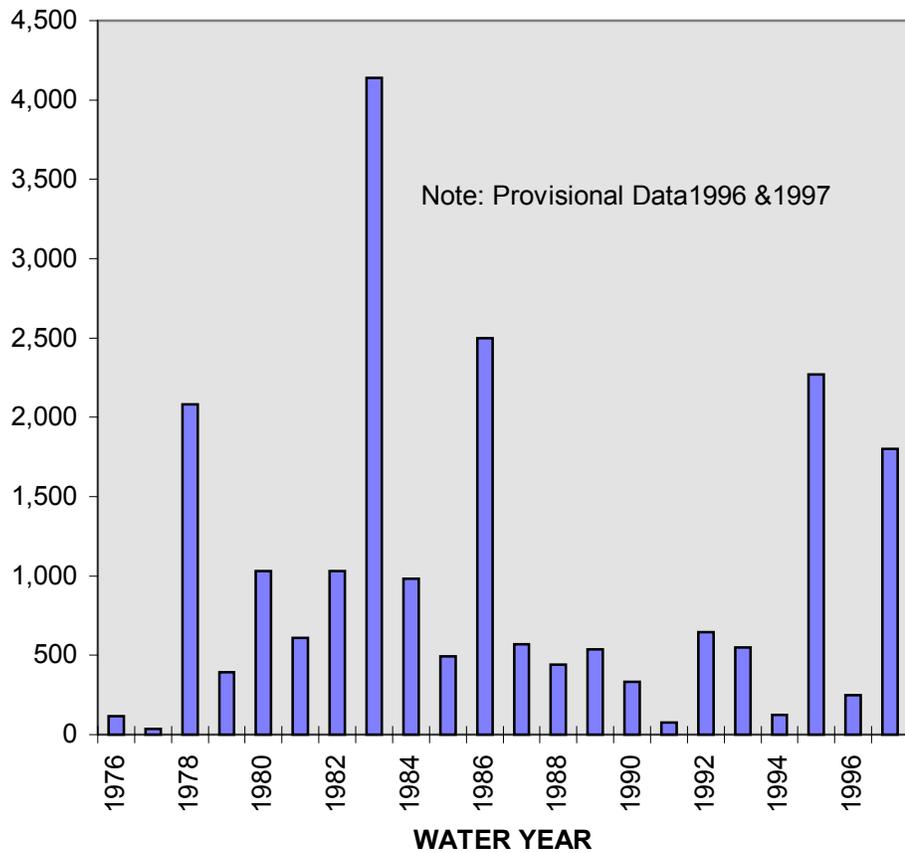
The best measure of effectiveness that can be made to date is comparing the sediment accumulation in Buckhorn Sediment Dam and Hamilton Ponds after the 1995 and 1997 storm events (Figure 7-1). Because no restoration work has been undertaken upstream of the dam, the sediment accumulation in the reservoir will serve as a good measure of erosion from untreated areas. Because the 1995 storm occurred during the middle of the program, many sites had not been treated. Also many of the sites which involved stream crossing excavations experienced a great deal of erosion (see road removal section). The storm did occur at a good time, however, as it proved without a doubt that large channel excavations should not be undertaken in decomposed granite (DG) without including stabilization measures in the excavated channel. Since the 1995 storm, channel stabilization measures have been incorporated into all stream crossing excavations. No significant erosion was observed from any of the stream crossing excavations with channel stabilization after the 1997 storm.

Figure 7-1. Maximum Instantaneous Peak Discharge from Grass Valley Creek at Fawn Lodge (1976-1997).
